# THE DOME OF THE ROCK IN JERUSALEM

A Description of its Structure & Decoration

ERNEST TATHAM RICHMOND

FELLOW OF THE ROYAL INSTITUTE OF BRITISH ARCHITECTS  
CONSULTING ARCHITECT TO THE NOBLE SANCTUARY IN JERUSALEM

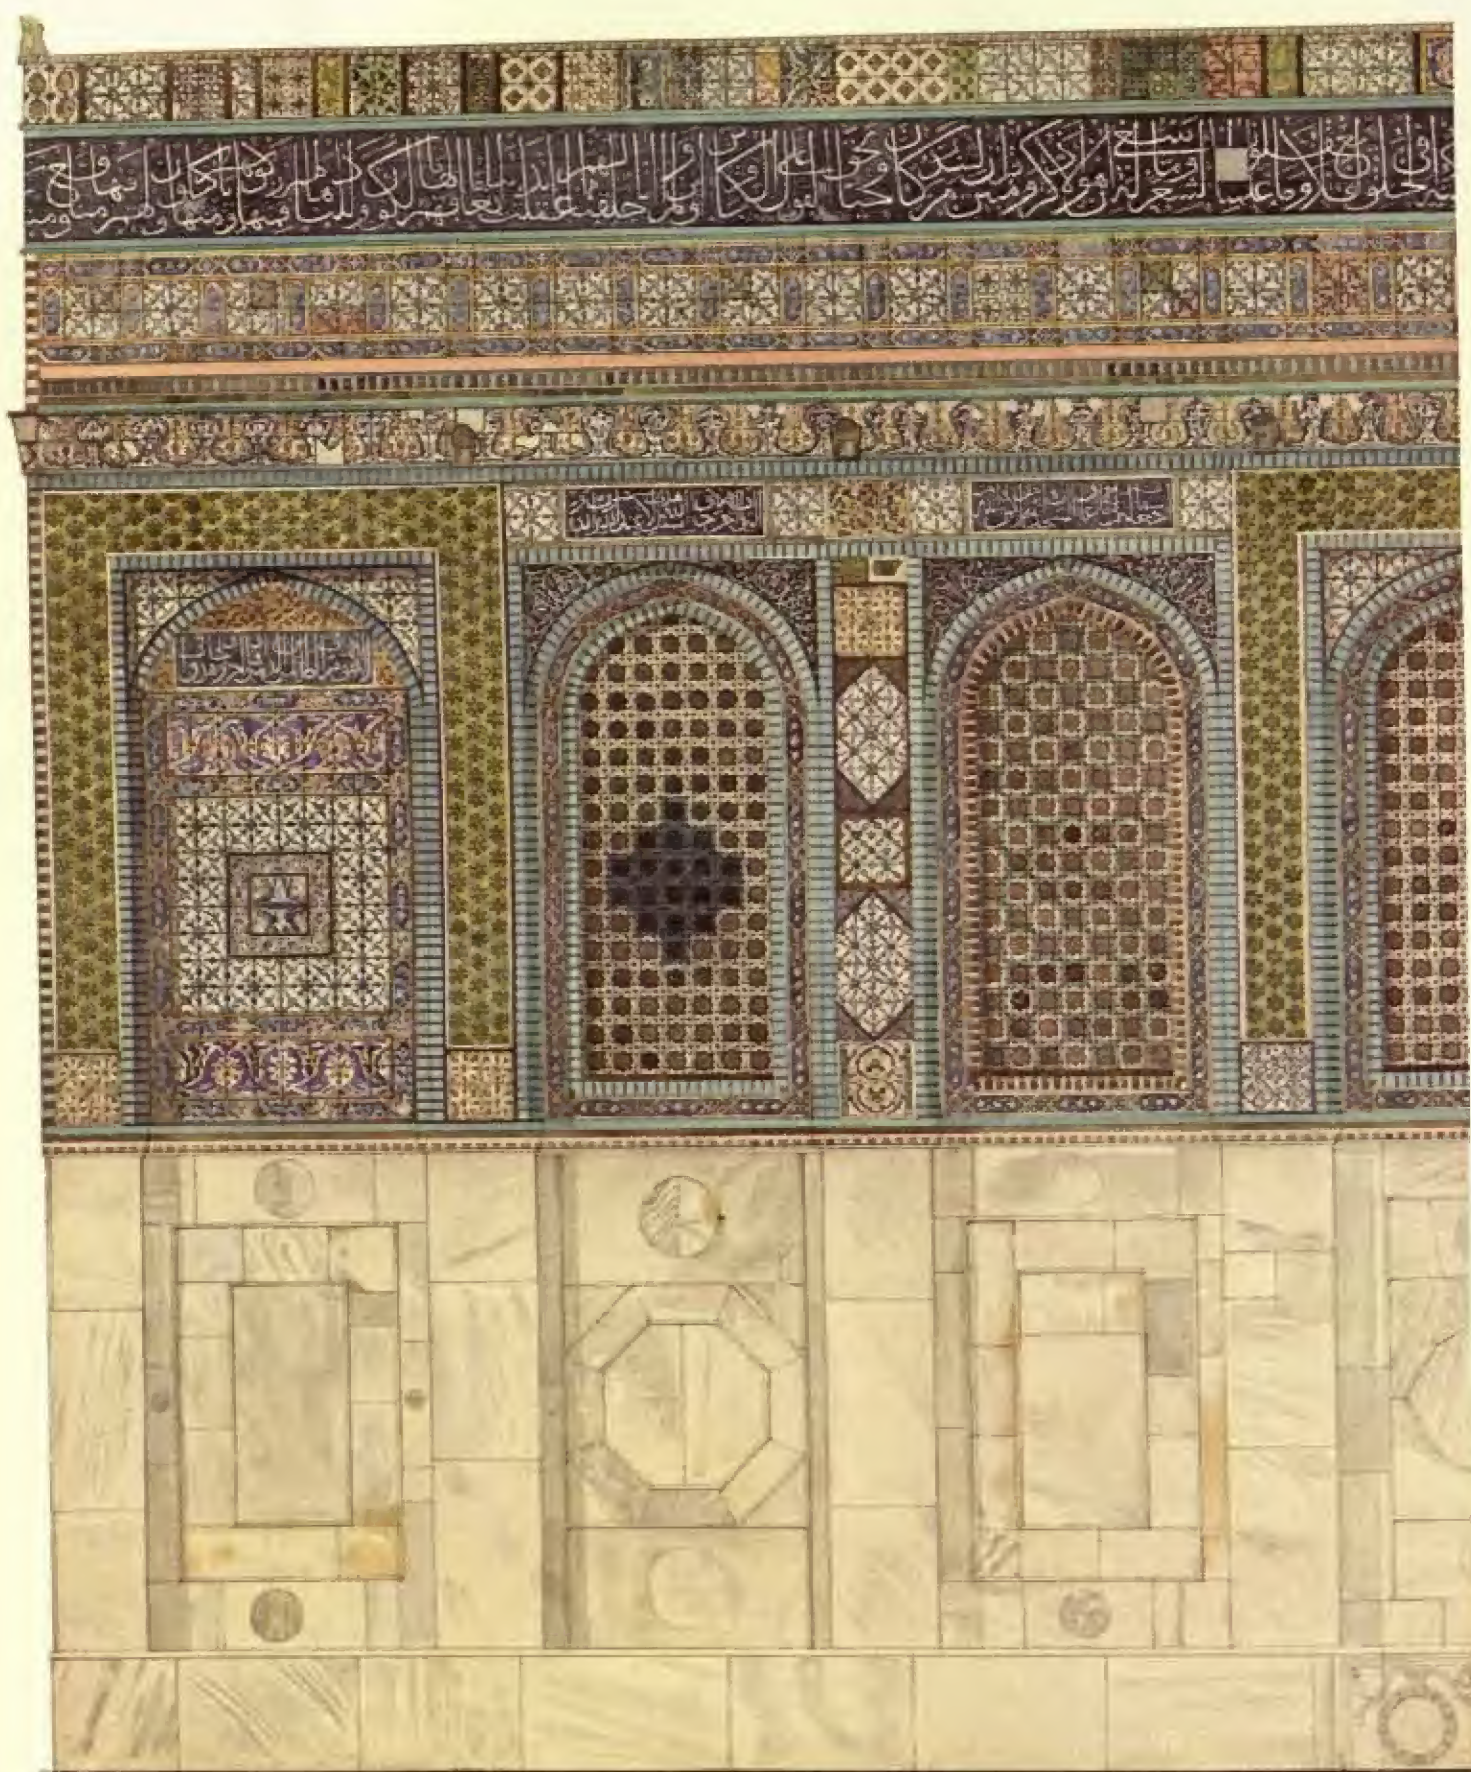
North-East face of Octagon. Three Bays showing present condition

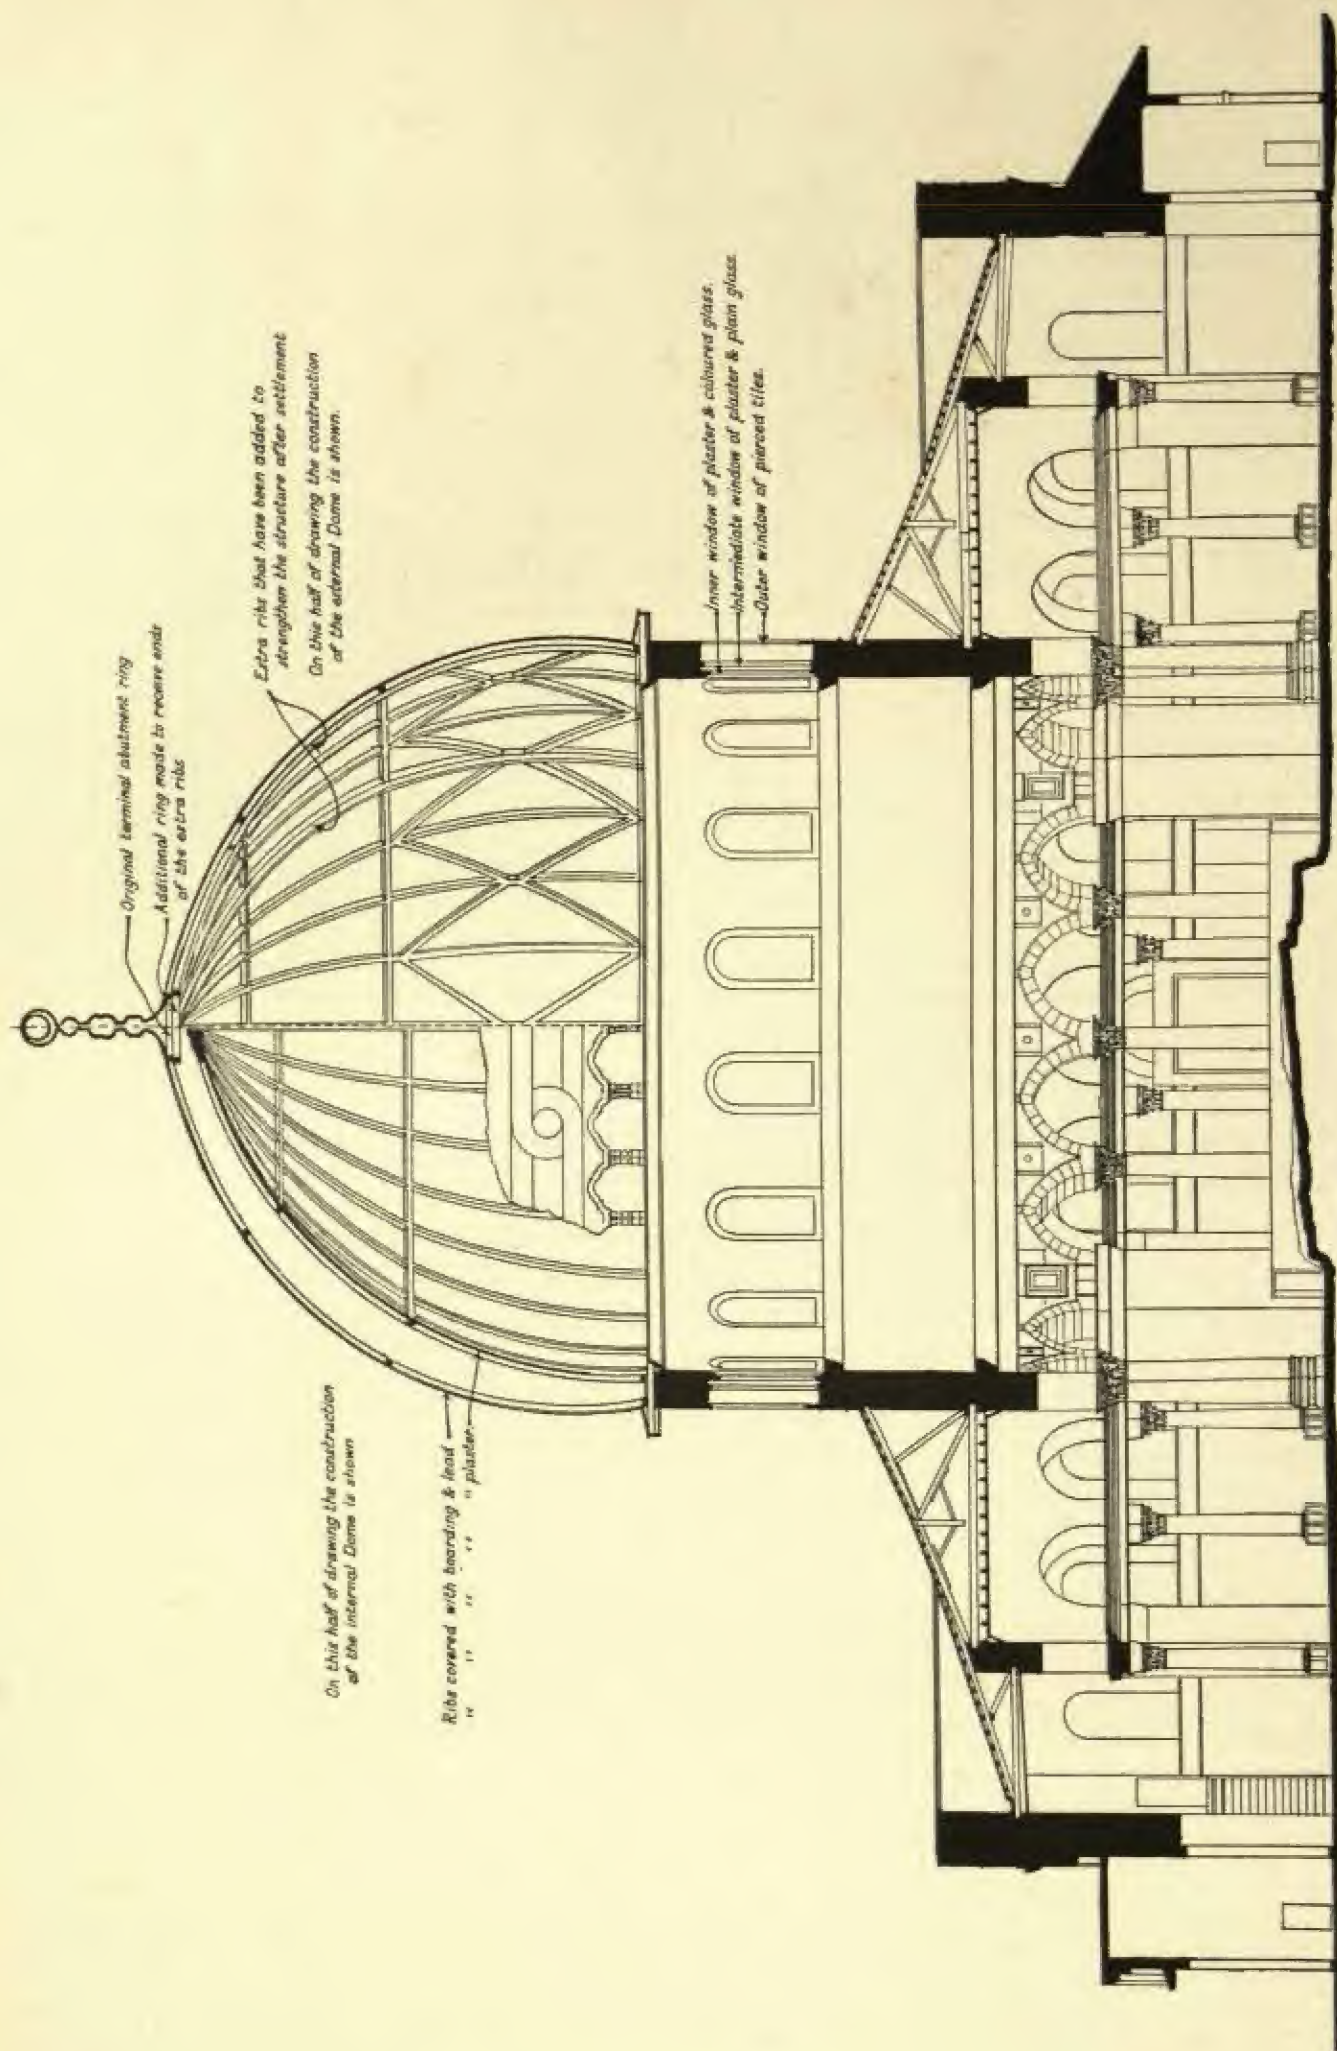
Diagram showing the relationship between the height (about 8.87 metres) of the main supports of the Drum & the following dimensions

- (i) Span of Dome = 8.87 x 3 (See A.A.)
- (ii) Height of Drum from floor = 6.87 x 3
- (iii) " " " " =  $\sqrt{(6 \times 6.87)^2 - (3 \times 6.87)^2}$
- (iv) " " " " =  $\sqrt{(2 \times 6.87)^2 - 6.87^2}$
- (v) " " to springing of arches of Drum windows =  $\sqrt{(3 \times 6.87)^2 - (1.5 \times 6.87)^2}$

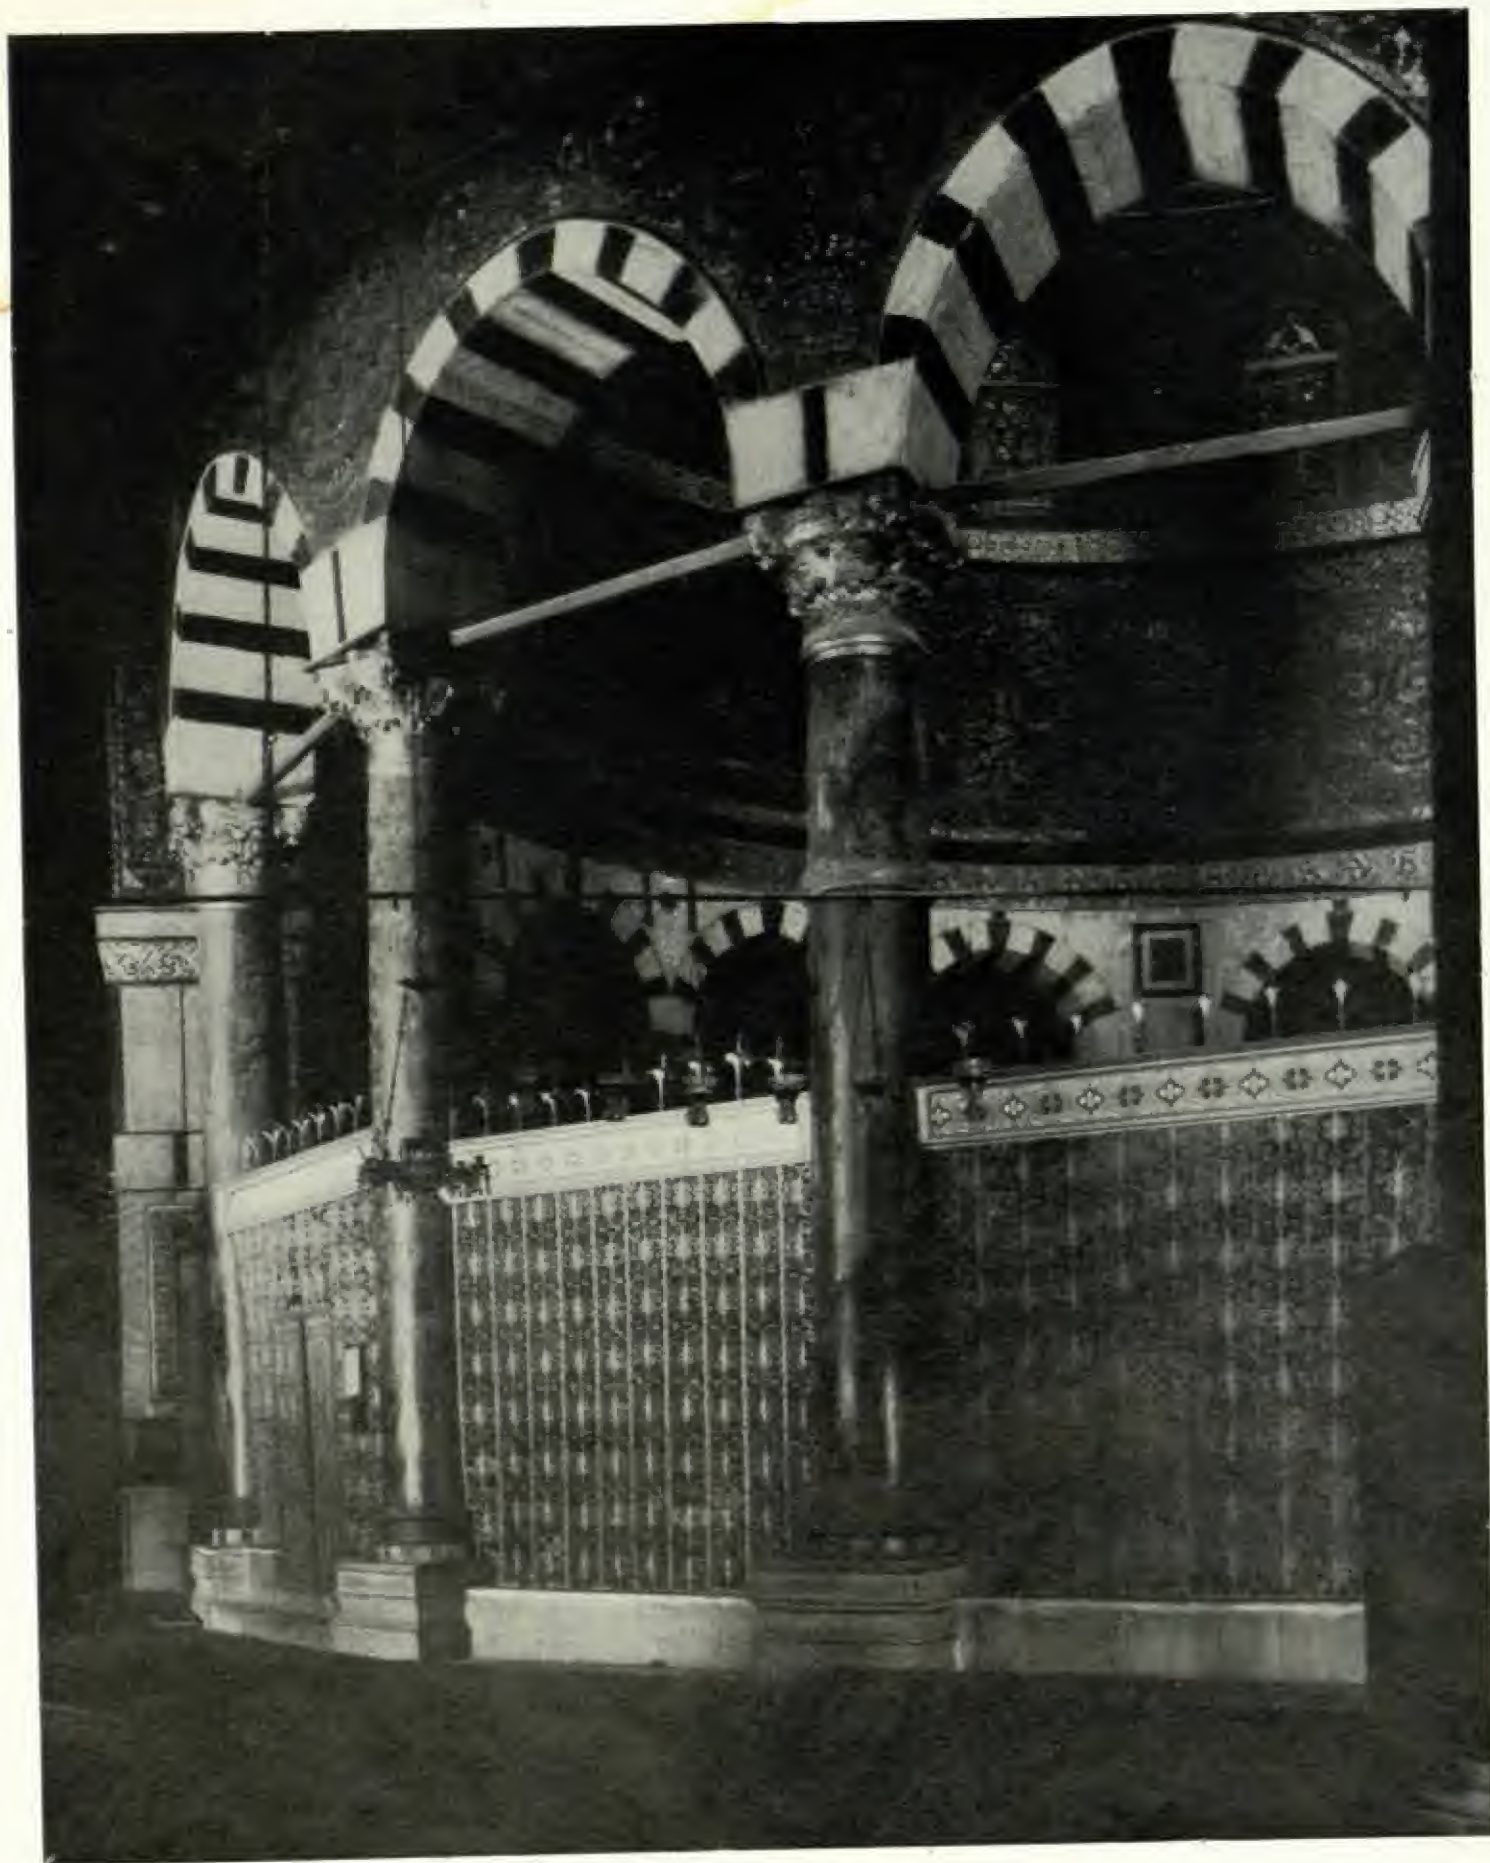
Fig. 3. A view of the columns and piers supporting the drum

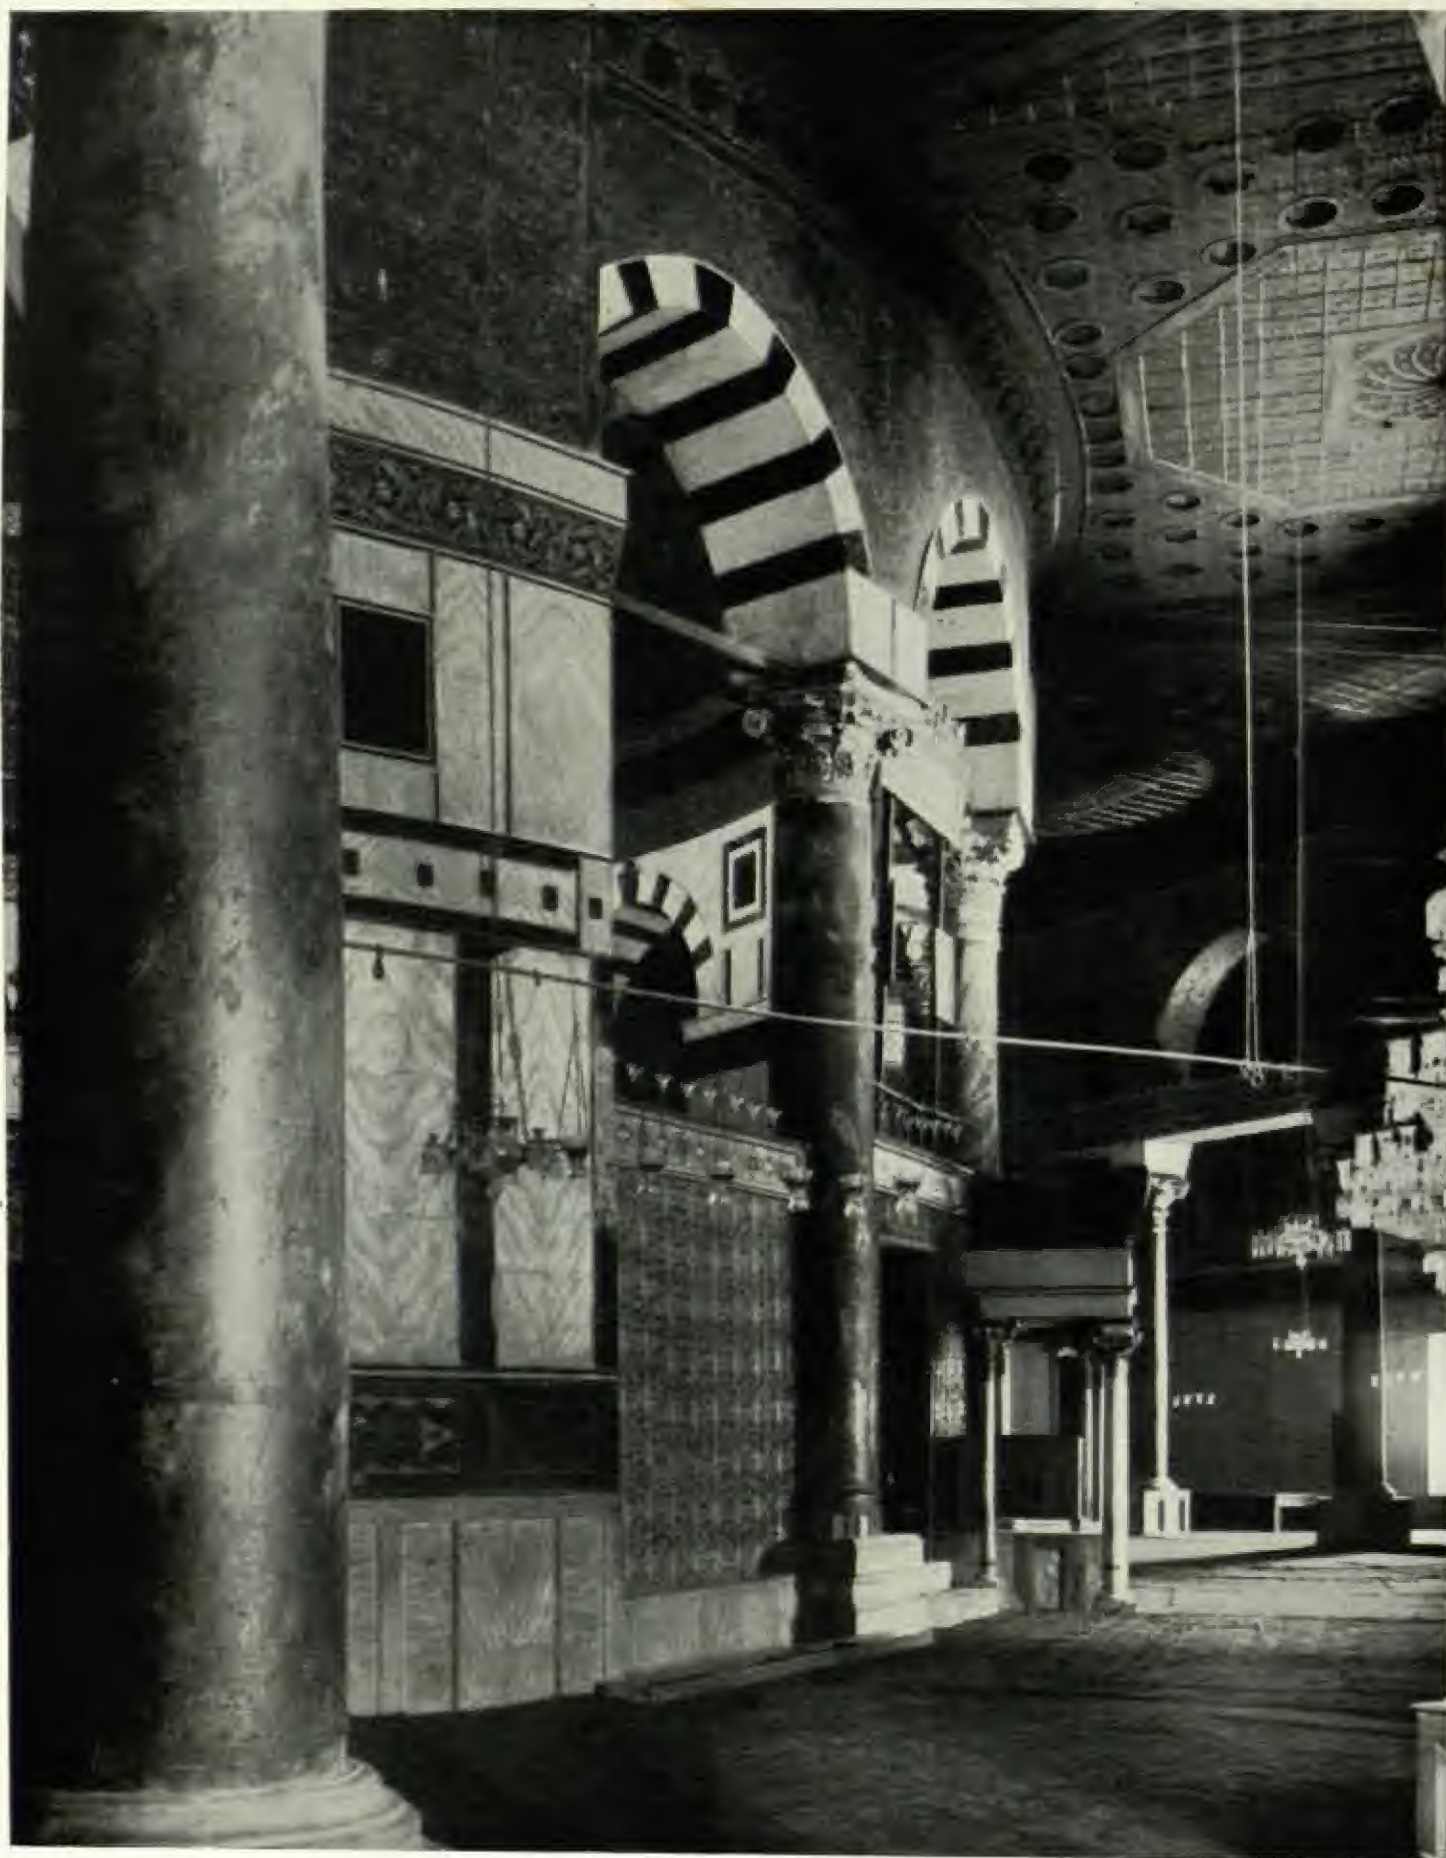
Fig. 4. A view of the columns and piers carrying the drum and, in the distance, of the arched colonnade between the outer wall and the drum supports

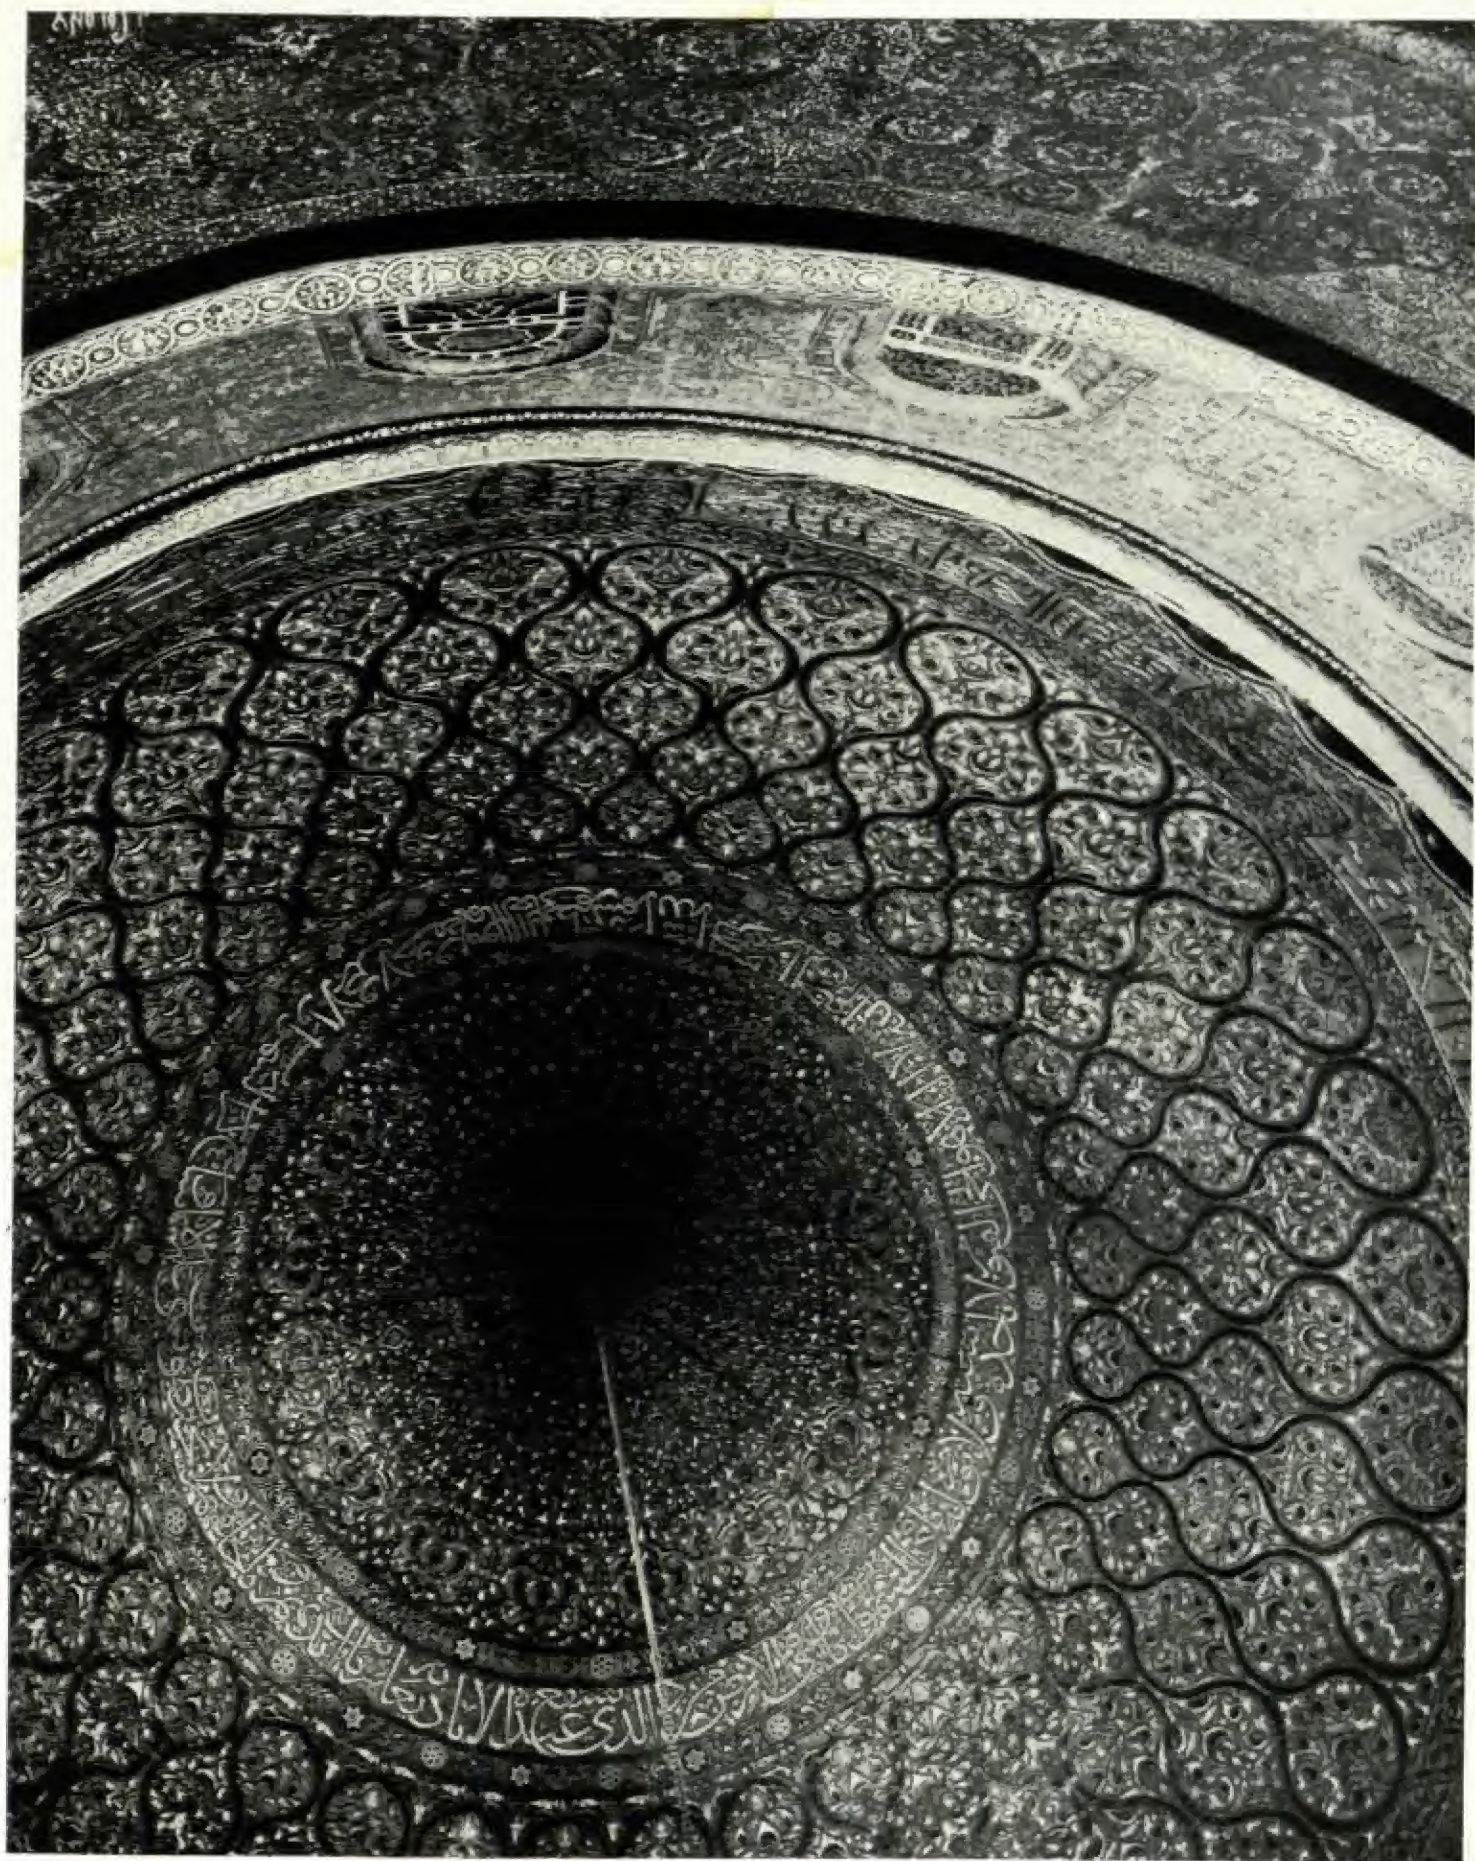
Fig. 8. Interior of the Dome showing the ornament of gilded and painted plaster work

black, blue, and green, and mother-of-pearl, set upon a gold background; the dome (Figs. 8, 9) is decorated with painted and gilded arabesques and inscriptions; marble covers the walls of the outer octagon and of the piers; and the window-openings are filled with coloured glass. An astonishingly rich and varied effect of structure, of ornament, and of light is thus produced. Looking across the building from one side to the other, the great swell of the cylindrical wall or drum is seen through an arch in the foreground. The many columns that carry the drum, together with those that are seen beyond and to the right hand and to the left, with their arches and their lines of gilded cornice, produce a crowded complex of structural forms that gives, by contrast, an appearance of impressive spaciousness to the area enclosed by the drum and, consequently, of great size to the dome, although the dome is, in comparison with other famous domes, but of modest span. Externally also the dome dominates (Fig. 14). But here the relationship between the dome and the enclosing octagon and the value given by the one to the other, is not so obvious as internally; and, though the building is, outside, less impressive than inside, yet its surface decoration—the lower part in marble and the upper part in Persian tiles—must, at one time, have been hardly less brilliant than that of the interior.

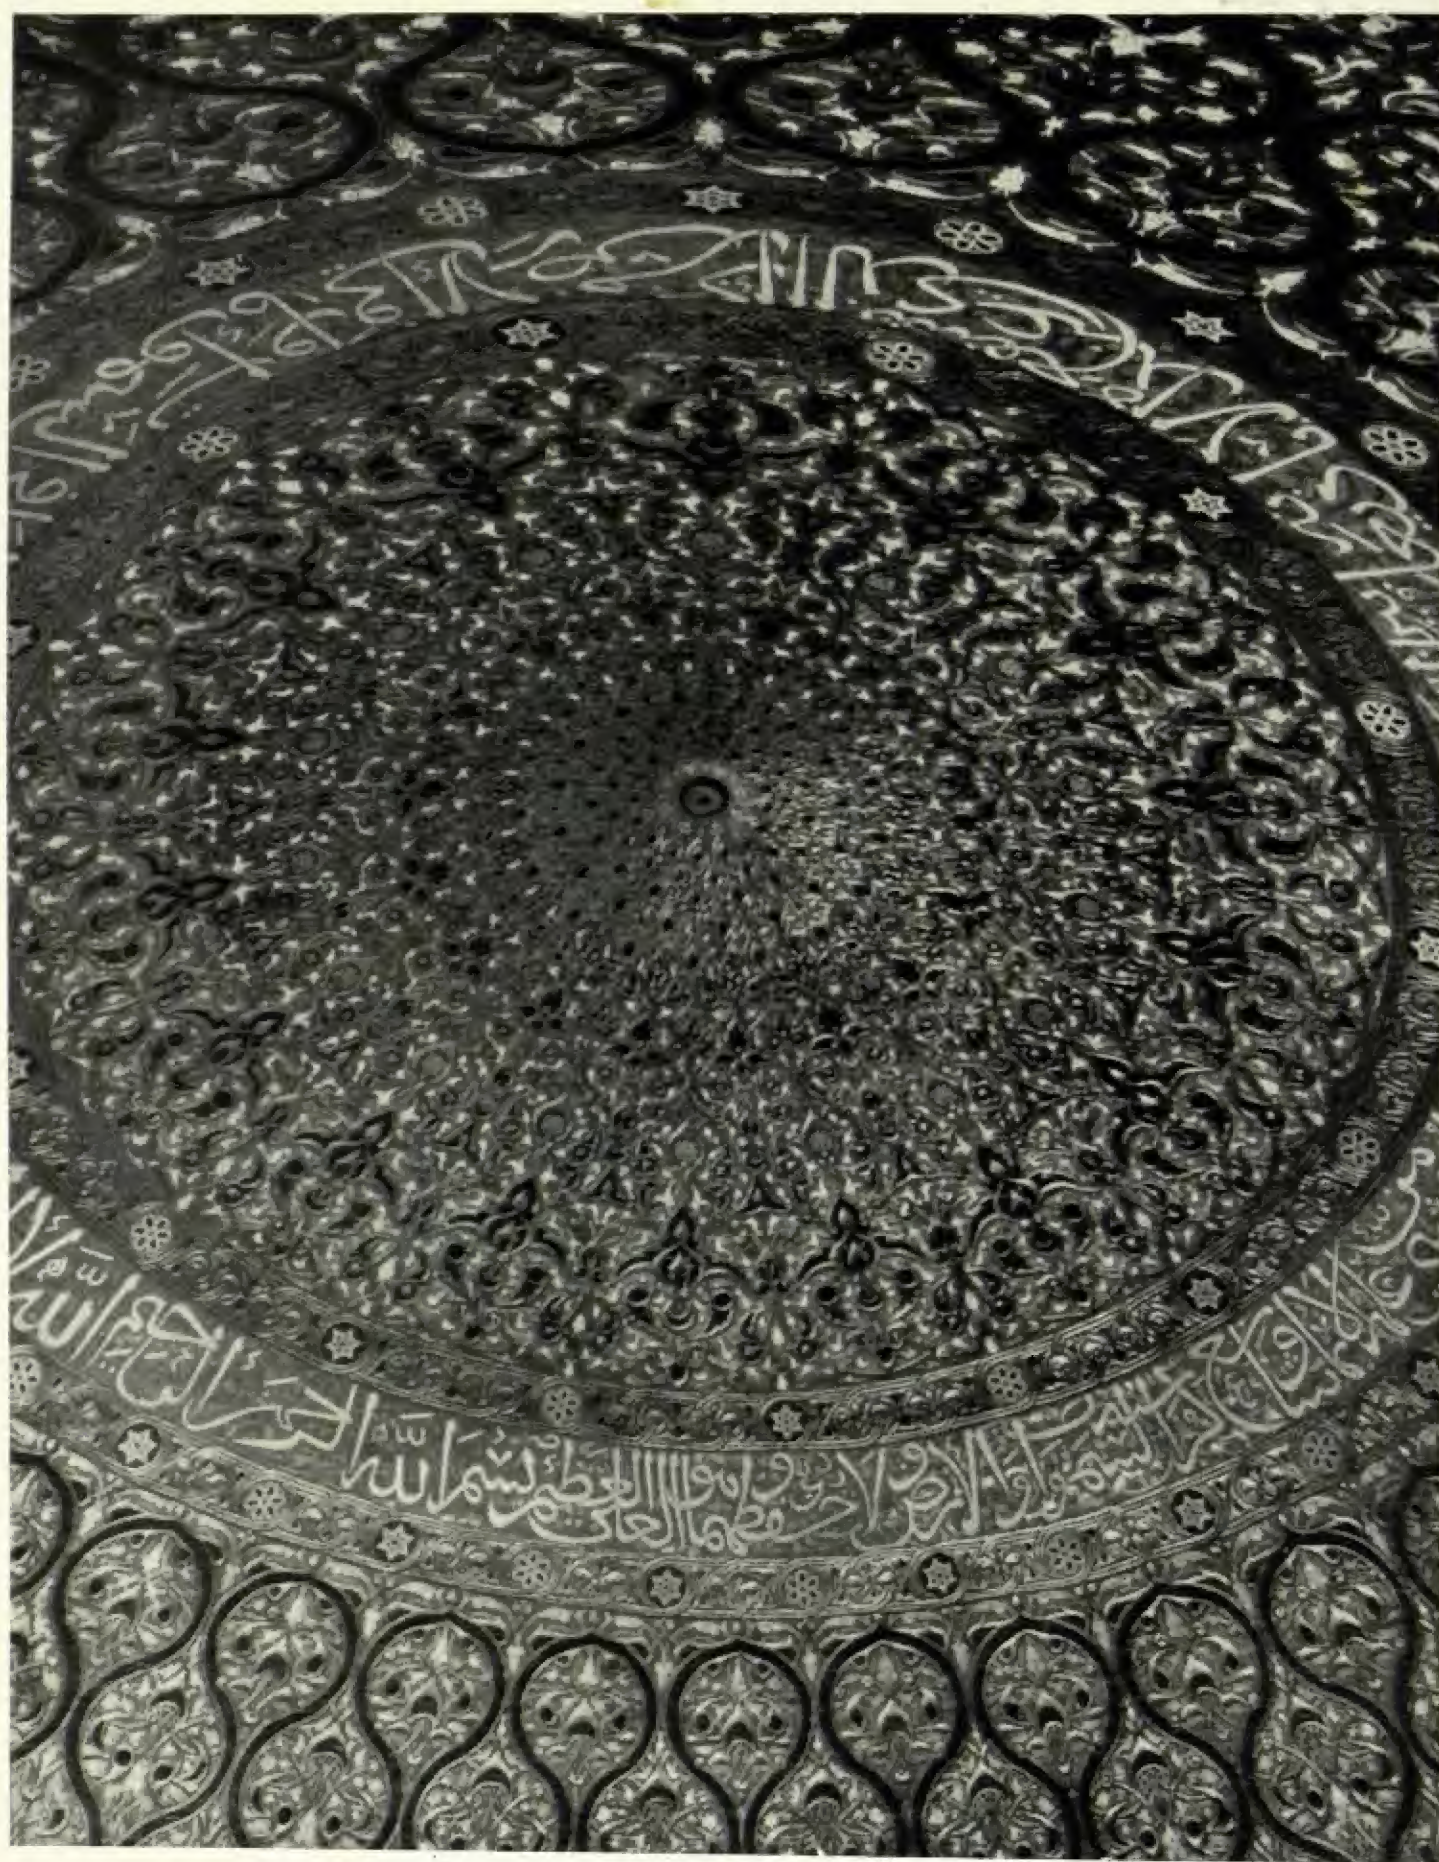
Fig. 9. A view of the Dome showing the decoration of its upper part

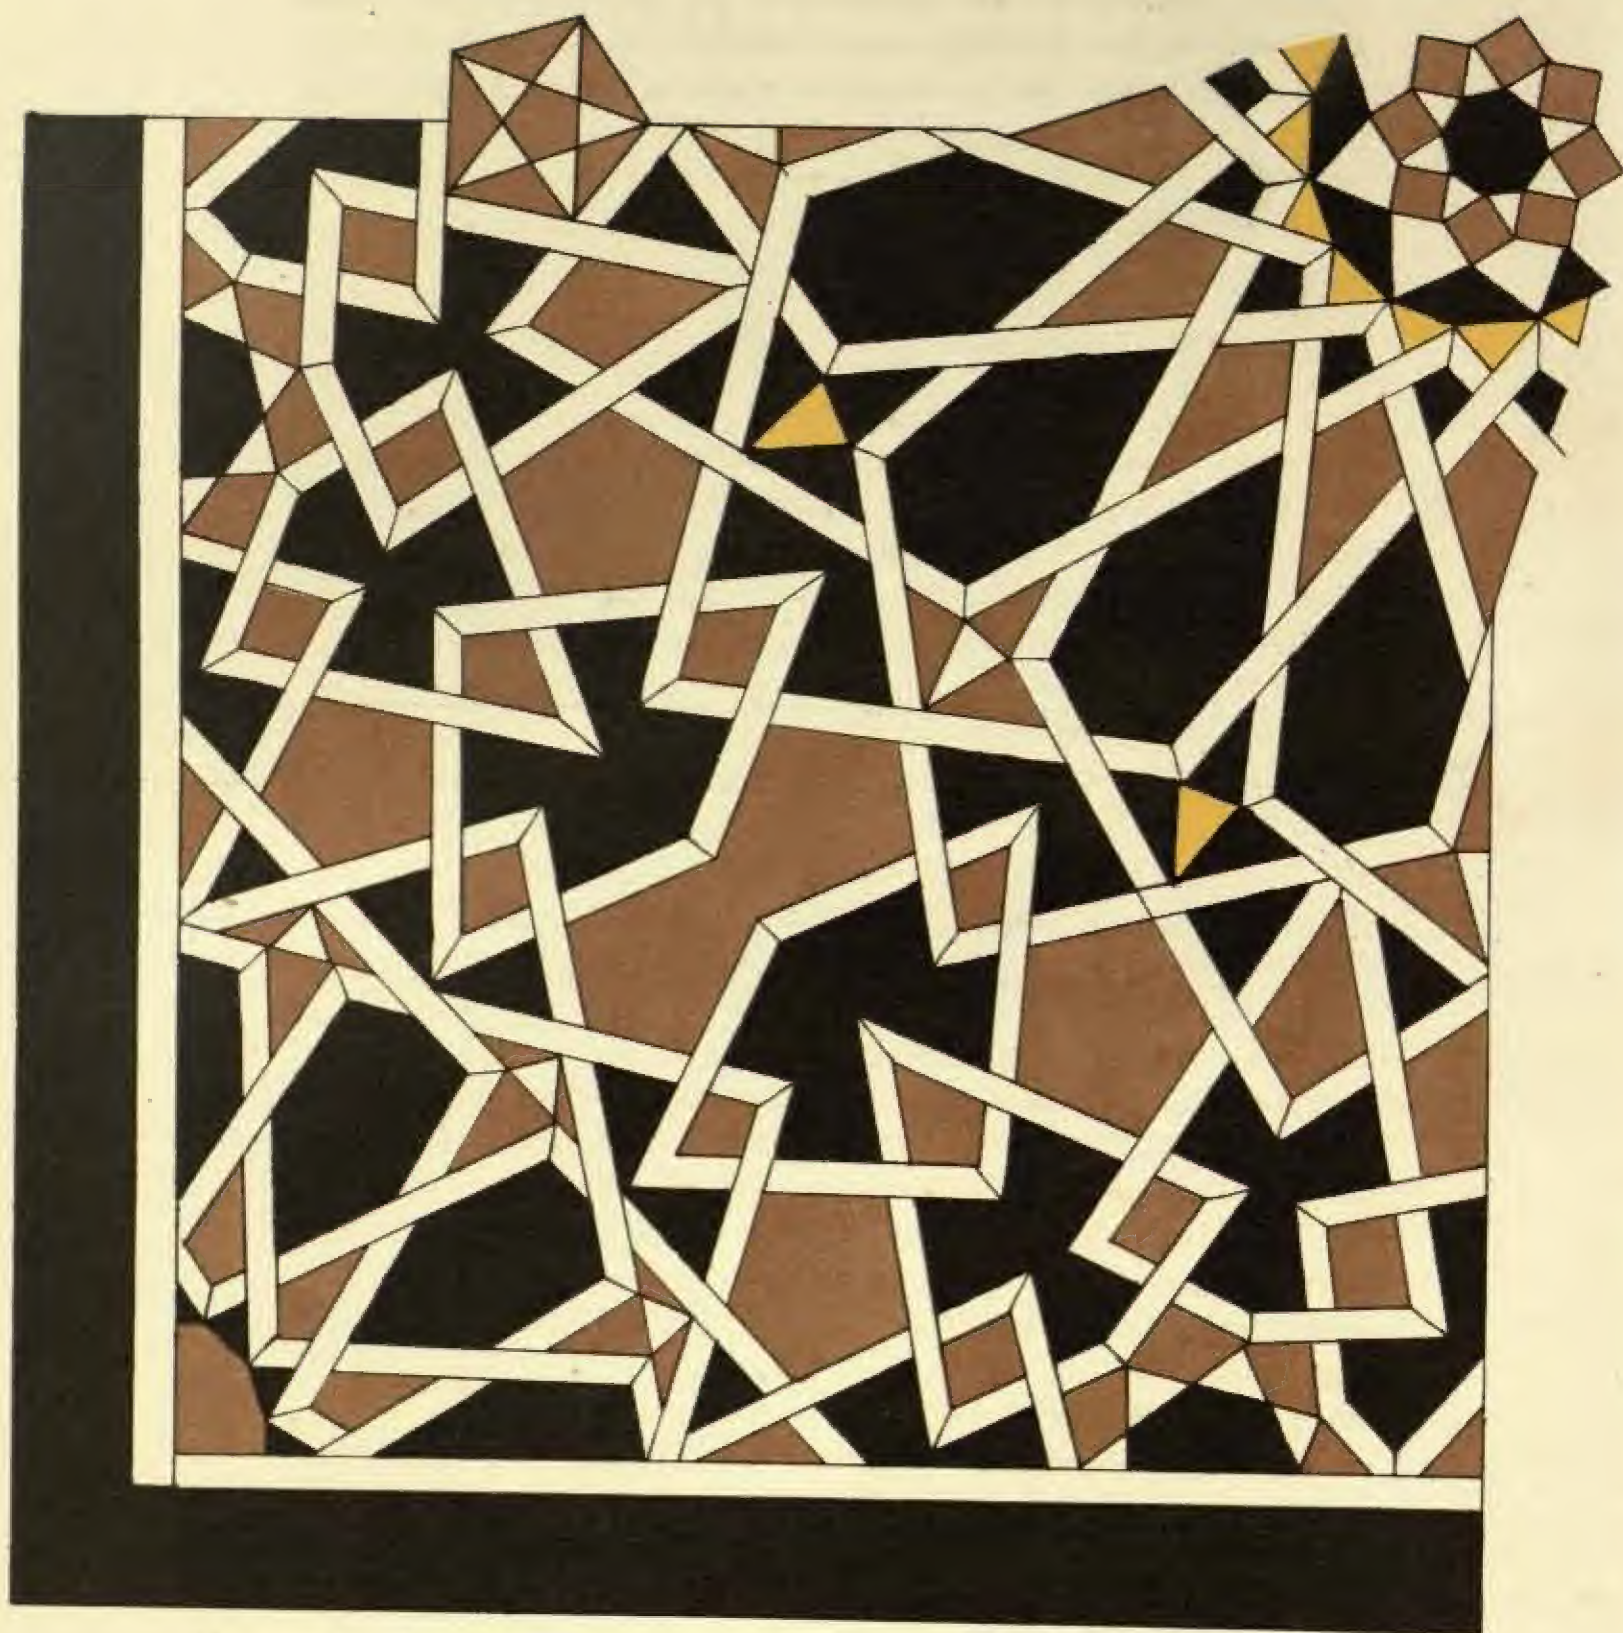
Fig. 11. One quarter of a tessellated pavement opposite the southern door

Scale 1:7.5

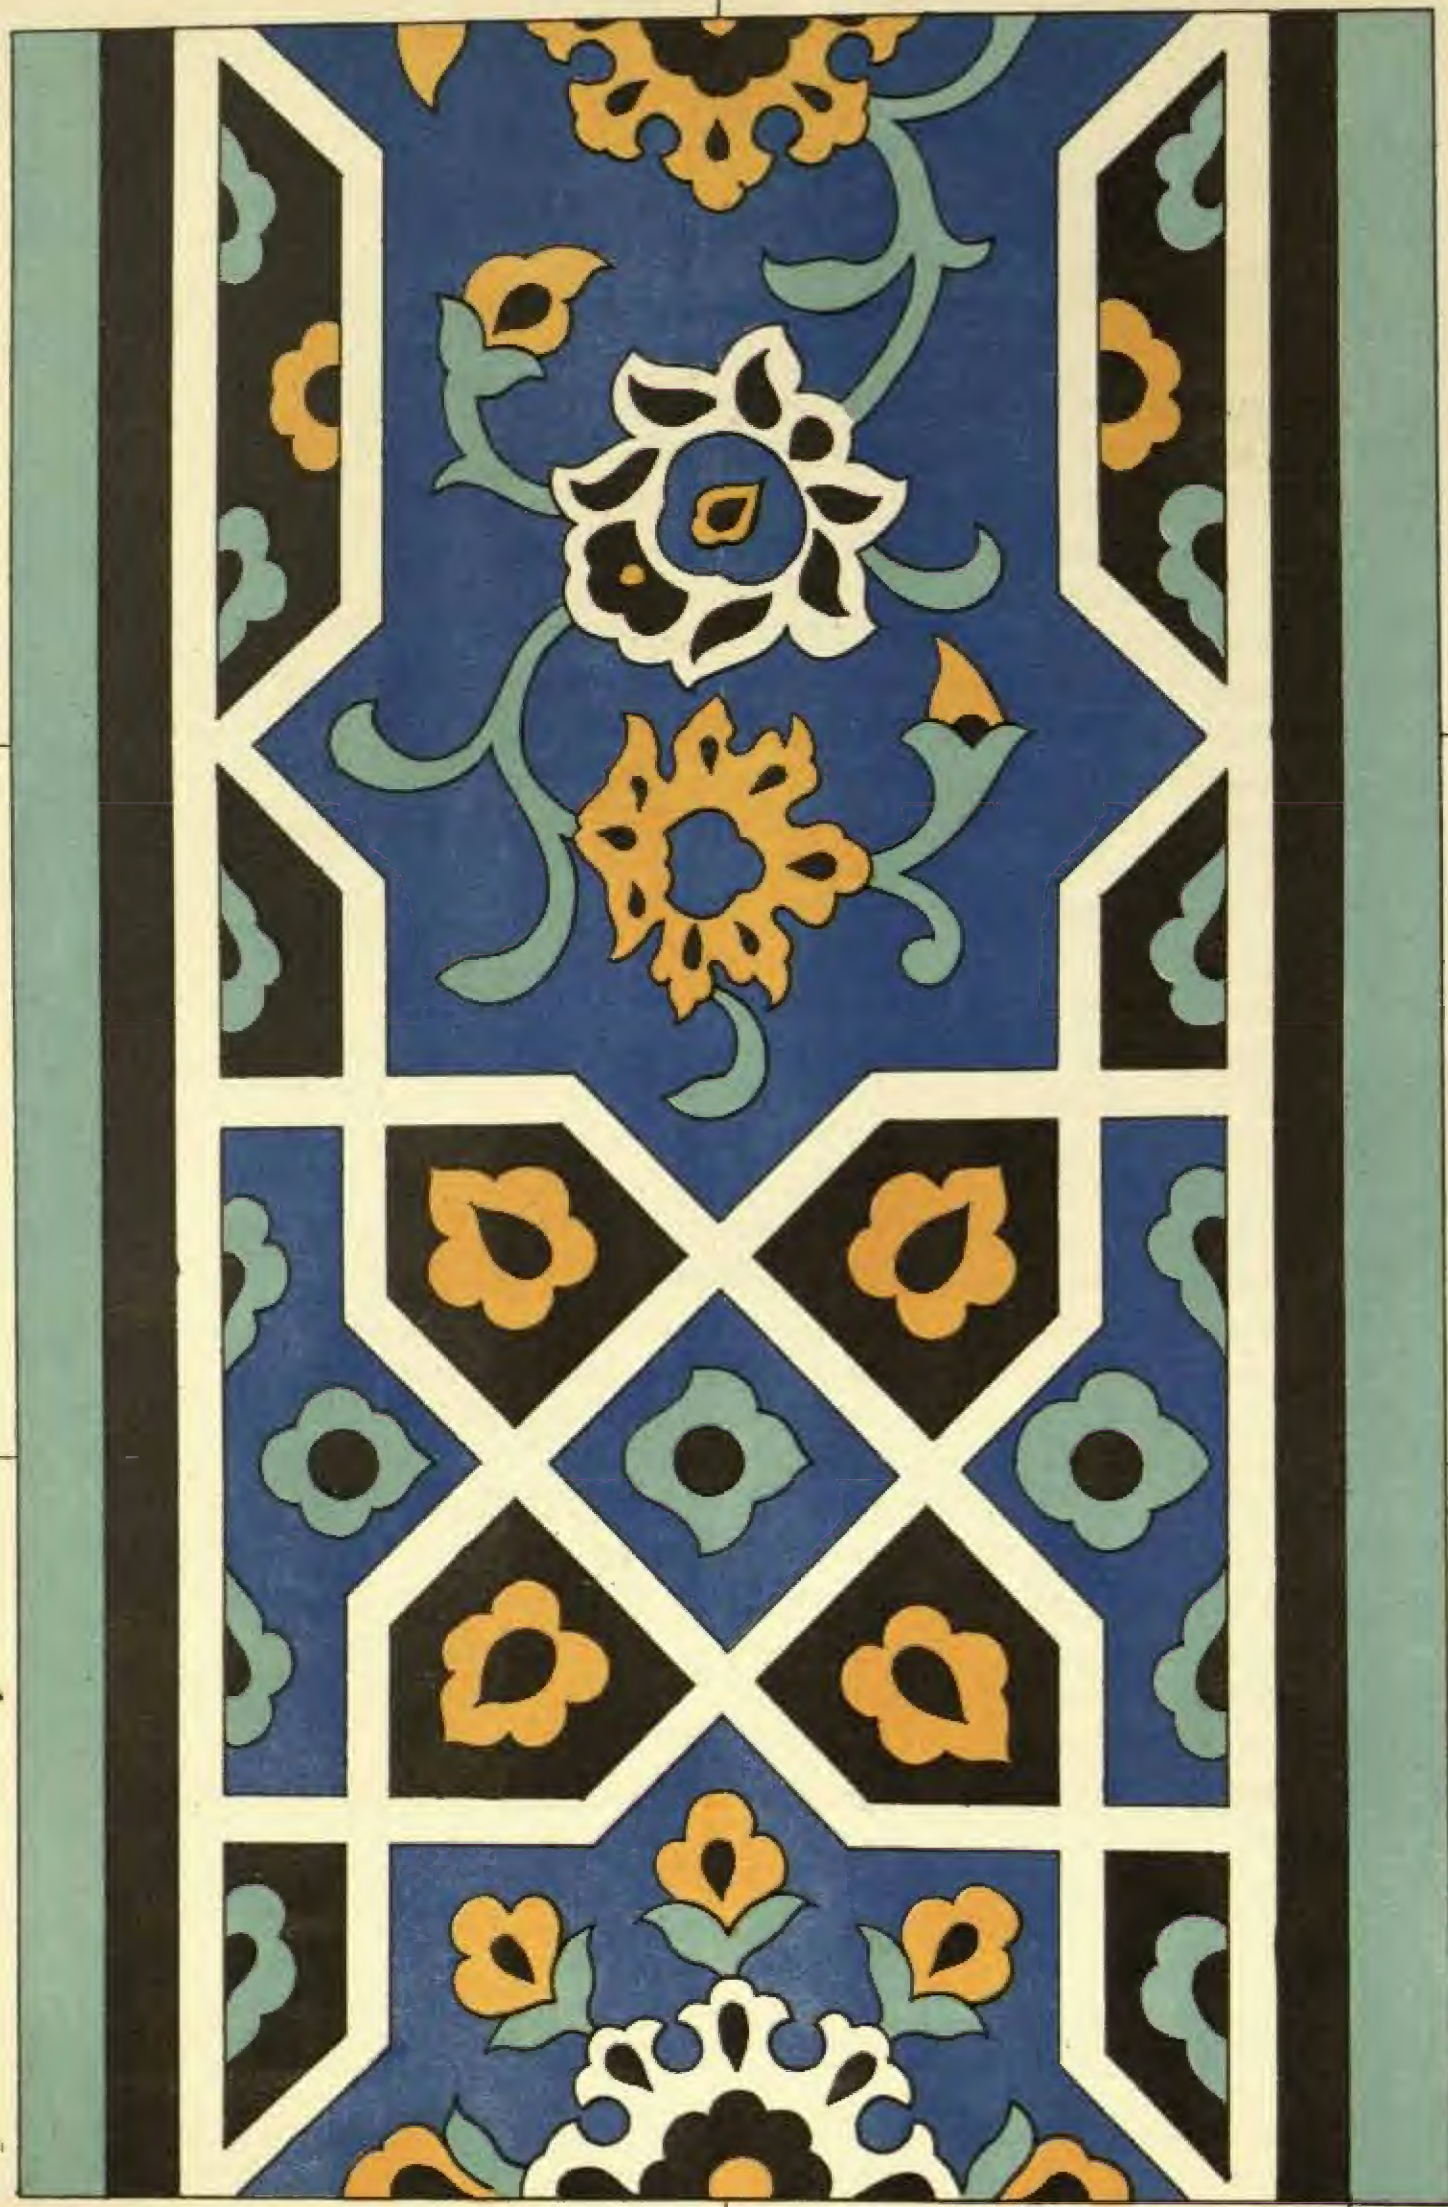
Fig. 16. Tiles of the First Period, showing a strong colour effect.

Scale 1:2

The system followed in painting these tiles is different from that followed in painting all the other tiles found on the building. They have no glaze separate from the colour. The colours and the glaze were mixed together and then applied together by means of a brush; the outline of each of the coloured spaces forming the design is in black without glaze, and forms, as it were, a trench between the raised enamelled surfaces of the coloured spaces, thus preventing the colours from running together during baking.

The colour-effect is strong, almost violent; and the drawing is decided. The design is made to tell at a distance. Ten tiles are needed to make a complete unit of the design. This border pattern is at present found above and below the great inscription running round the drum, it also surrounds the windows of the drum and in part encircles the drum in a band between the window-sills and the lead roof of the octagon. Though there is no reason to suppose that this disposition does not fulfil the intention of the original designers, it is clear that the tiles have been reset, for practically all have been readjusted and reduced by chiselling.
